REPORT NO. RD-64-46

EVALUATION
OF
TAXIWAY CENTERLINE LIGHTING

FEDERAL AVIATION AGENCY

Systems Research & Development Service

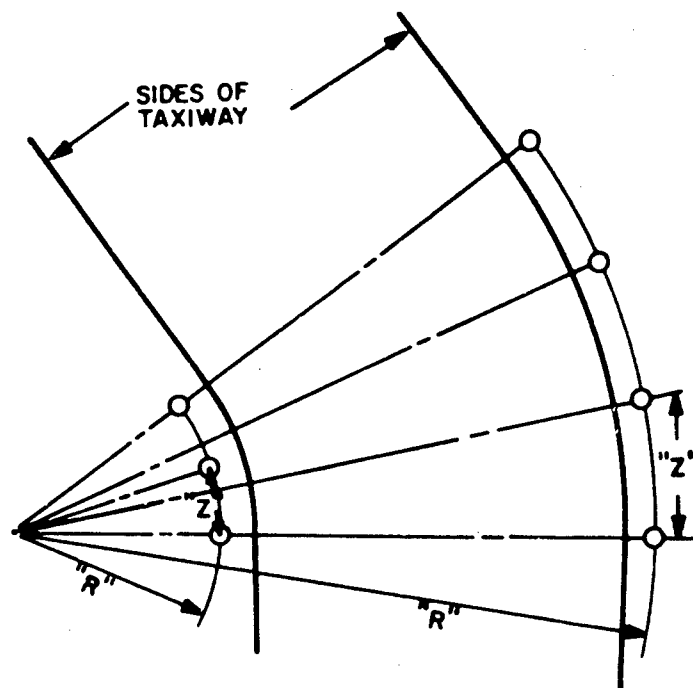
RADIUS "R" IN FEET	LIGHT SPACING "Z" IN FEET	RADIUS "R" IN FEET	LIGHT SPACING "Z" IN FEET
15	20	300	80
25	27	400	95
50	35	500	110
75	40	600	130
100	50	700	145
150	55	800	165
200	60	900	185
250	70	1000	200 MAX.

- NOTES: 1. FOR RADII NOT LISTED, "Z" SPACING SHALL BE DETERMINED BY LINEAR INTERPOLATION.
2. "Z" IS THE CHORD LENGTH.

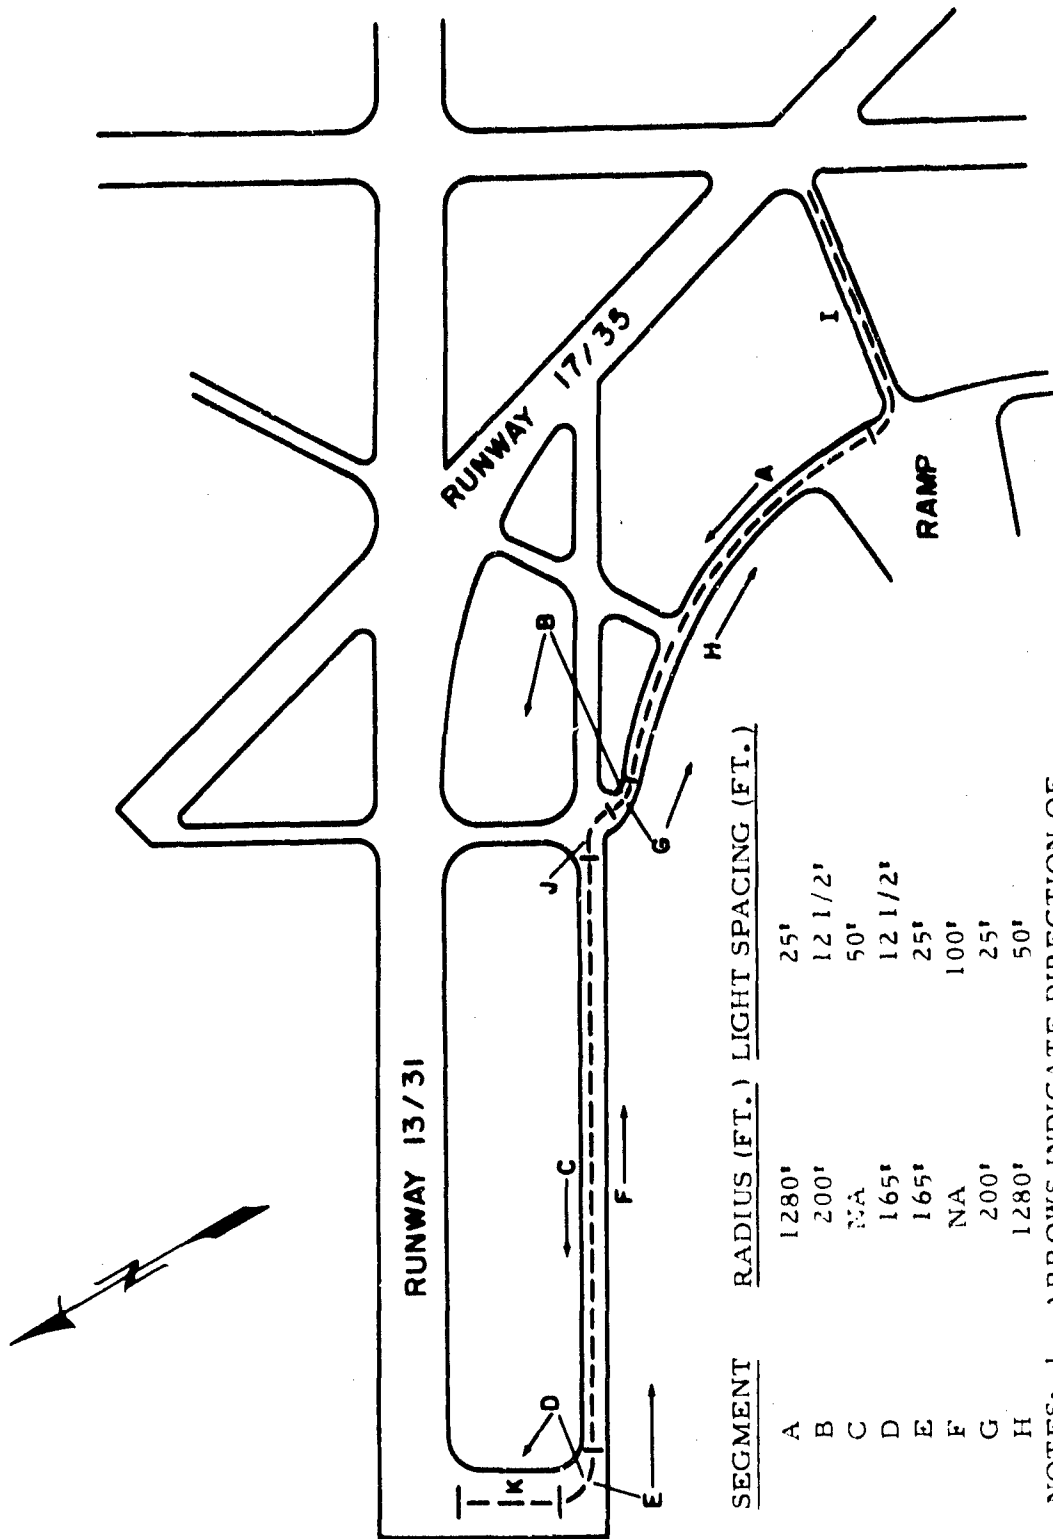
FIG. 2 LOCATION AND RADII OF TAXIWAY CURVES

SEGMENT	RADIUS (FT.)	LIGHT SPACING (FT.)
A	1280'	25'
B	200'	12 1/2'
C	NA	50'
D	165'	12 1/2'
E	165'	25'
F	NA	100'
G	200'	25'
H	1280'	50'

NOTES: 1. ARROWS INDICATE DIRECTION OF AIRCRAFT TRAVEL

2. SEGMENTS I, J, AND K WERE NOT USED IN THE TAXIING TESTS, THEREFORE NO DIRECTION OF TRAVEL NEED BE ASSOCIATED WITH THEM

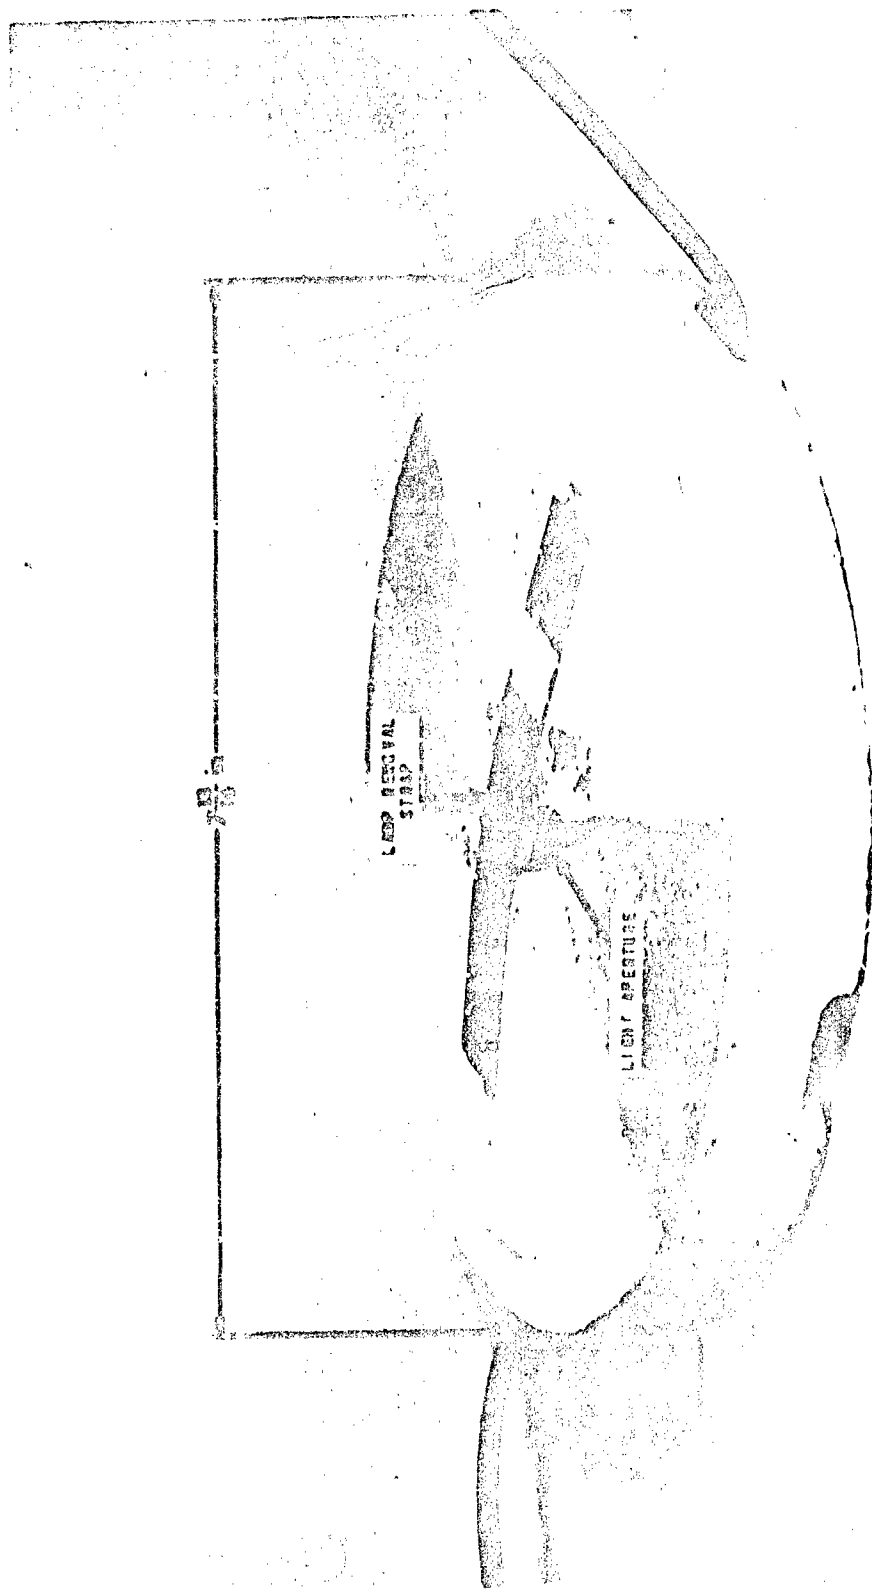
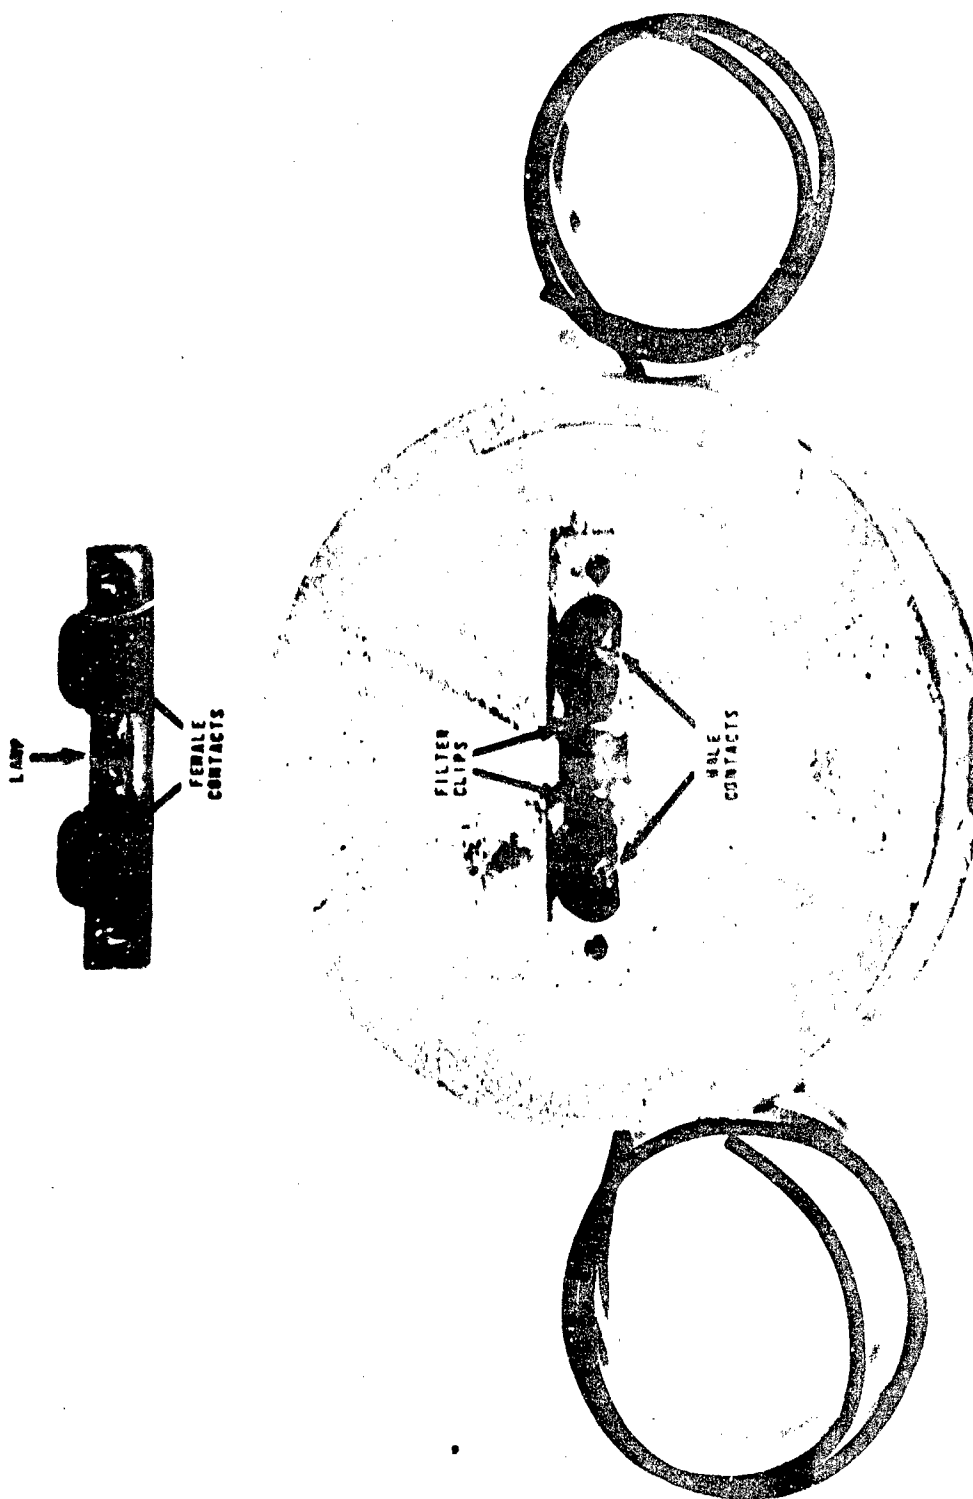
FIG. 4 STRUCTURAL ELECTRIC PRODUCTS CORPORATION FIXTURE

FIG. 5 STRUCTURAL ELECTRIC PRODUCTS CORPORATION FIXTURE
(LAMP STRAP REMOVED)

Structural Electric Products Corporation Fixtures - The Structural Electric Products Corporation fixtures (FIGS. 4 and 5) are connected in series circuits. A film cutout connected in parallel across the lamp provides a continuous circuit if the lamp should fail. The fixture is 7-13/16 inches in diameter and 1-1/4 inch high at the center. The fixture extends 1/4 inch above the runway surface when installed. Two "U" shape tension clips are riveted to the base of the fixture inside the lamp recess for holding colored filters in place. The lamp terminals are mounted in rubber.

Structural Electric Products Corporation Fixture: The tests made on these fixtures resulted in very few lamp burn-outs. Both the lamps and filters, however, accumulated thick films of dirt and numerous filters were cracked or broken. When the damaged filters were replaced, the filter clips, which had rusted, would break. Three of these fixtures had to be replaced because the male contact in the fixture base became electrically grounded. The grounding apparently was caused by poor electrical contact with the lamp strap, which in turn caused charring and pitting. Charring and pitting were also found in fixtures that had not failed. Finally, deposits of sand and dirt were found in the lamp strap recess of the base in all fixtures. It is evident that enclosing the lamp compartment of these fixtures with lenses or prisms would correct a number of the faults.

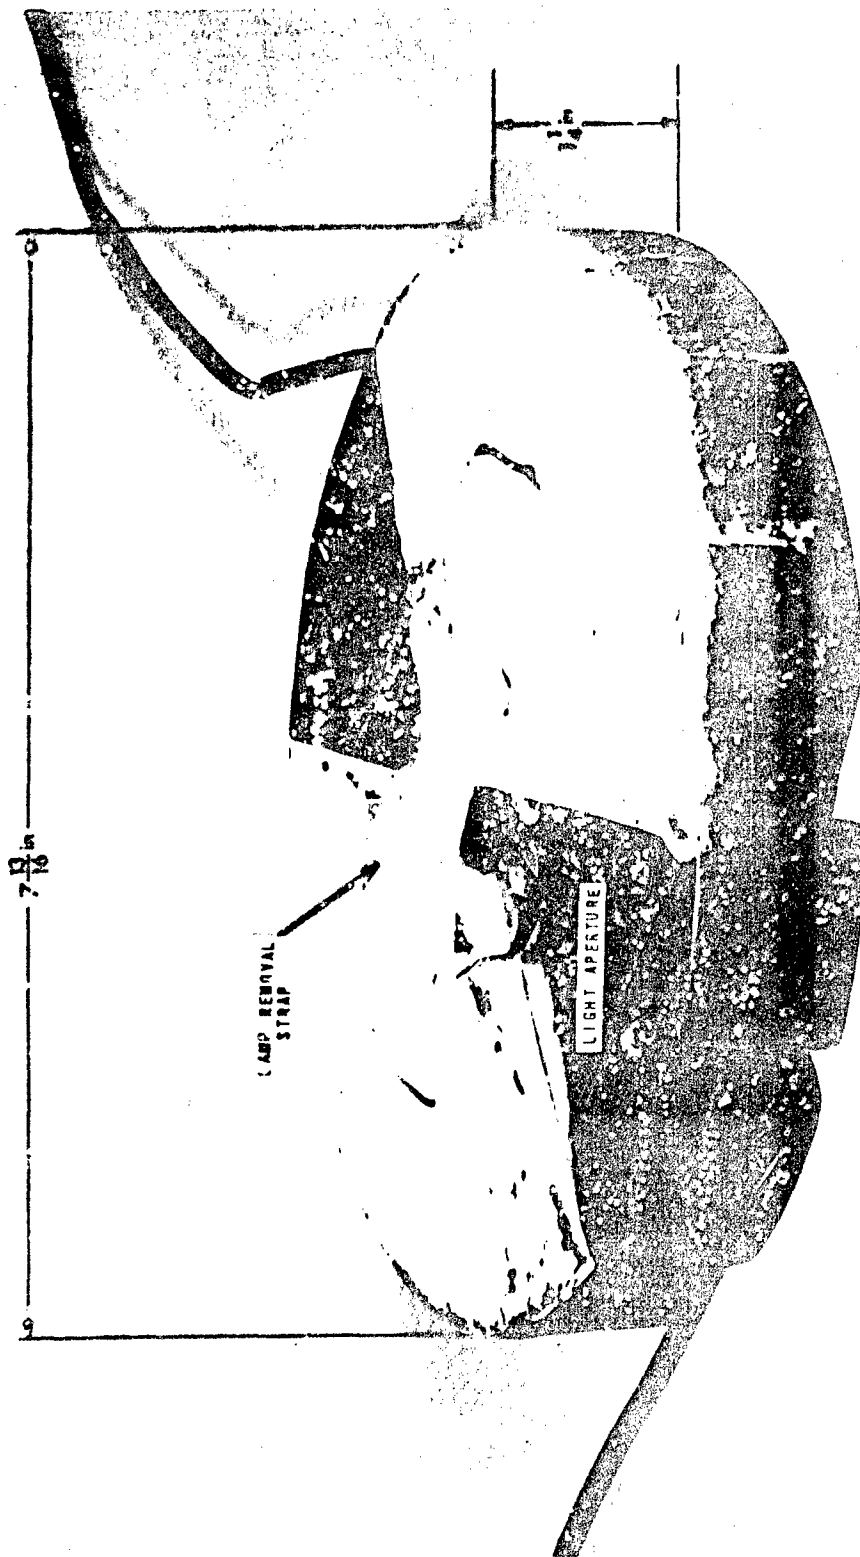
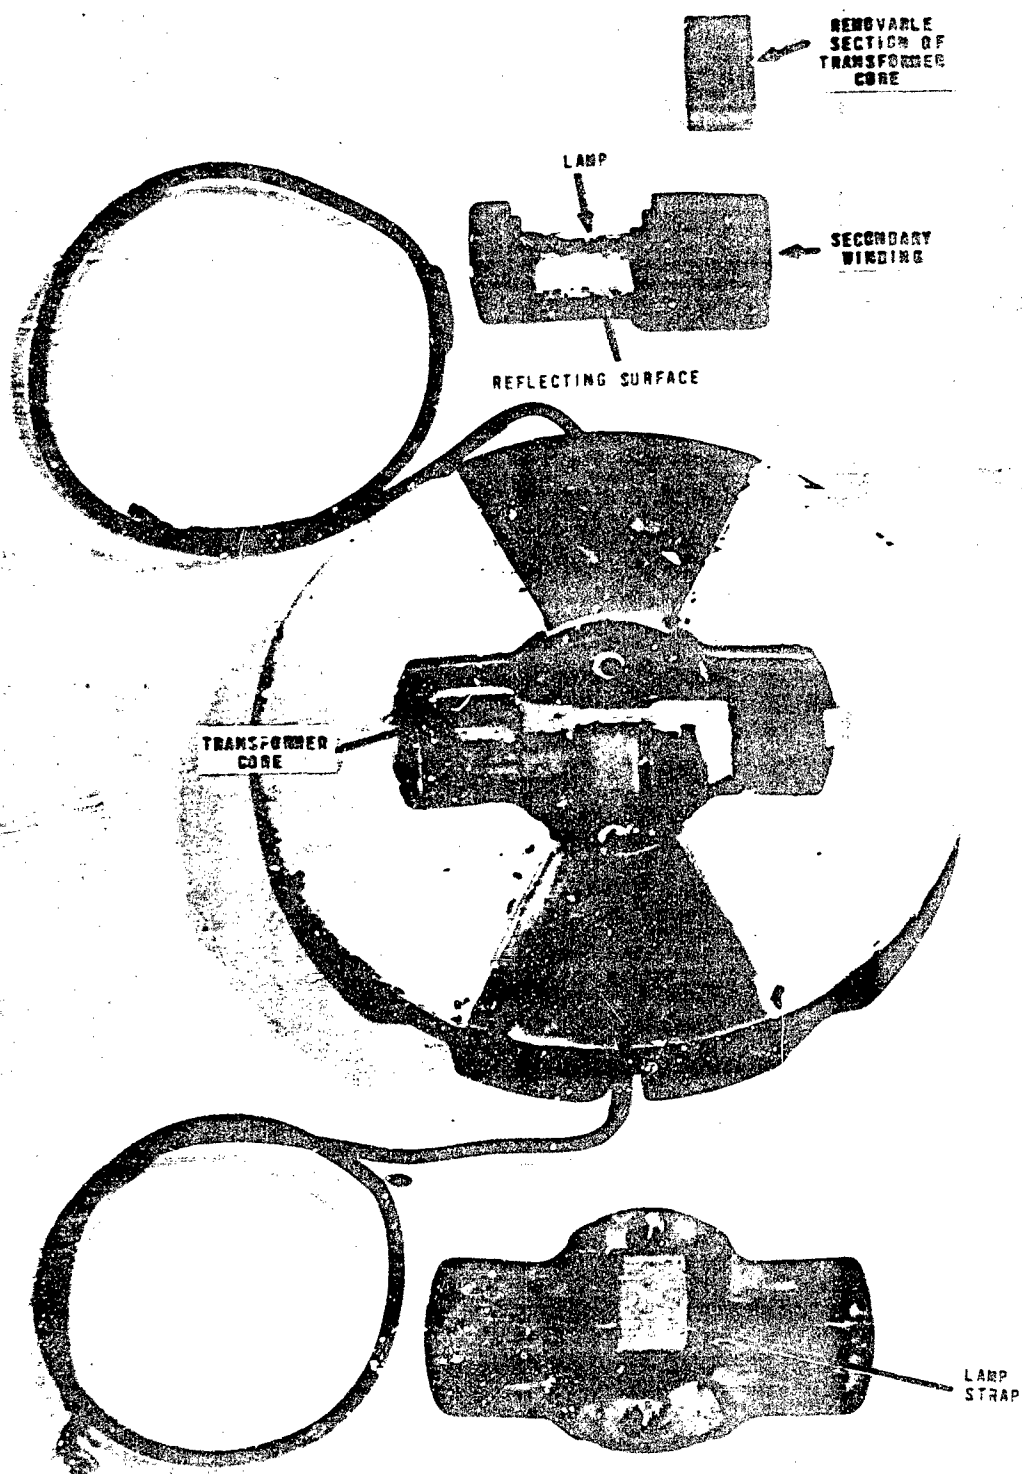
FIG. 6 STRONG ELECTRIC CORPORATION 7 13/16-INCH FIXTURE

FIG. 7 STRONG ELECTRIC CORPORATION 7 13/16-INCH FIXTURE
(LAMP STRAP REMOVED)

Strong Electric Corporation Fixtures - The Strong Electric Corporation fixtures are connected in series but do not require a film cutout because each unit contains a small isolating transformer. The primary of the small transformer is molded into the base of the fixture while the secondary winding, with the lamp connected, is in a removable lamping assembly. These fixtures were provided in two sizes. The larger fixture is 7-13/16 inches in diameter (FIGS. 6 and 7) and 1-1/2

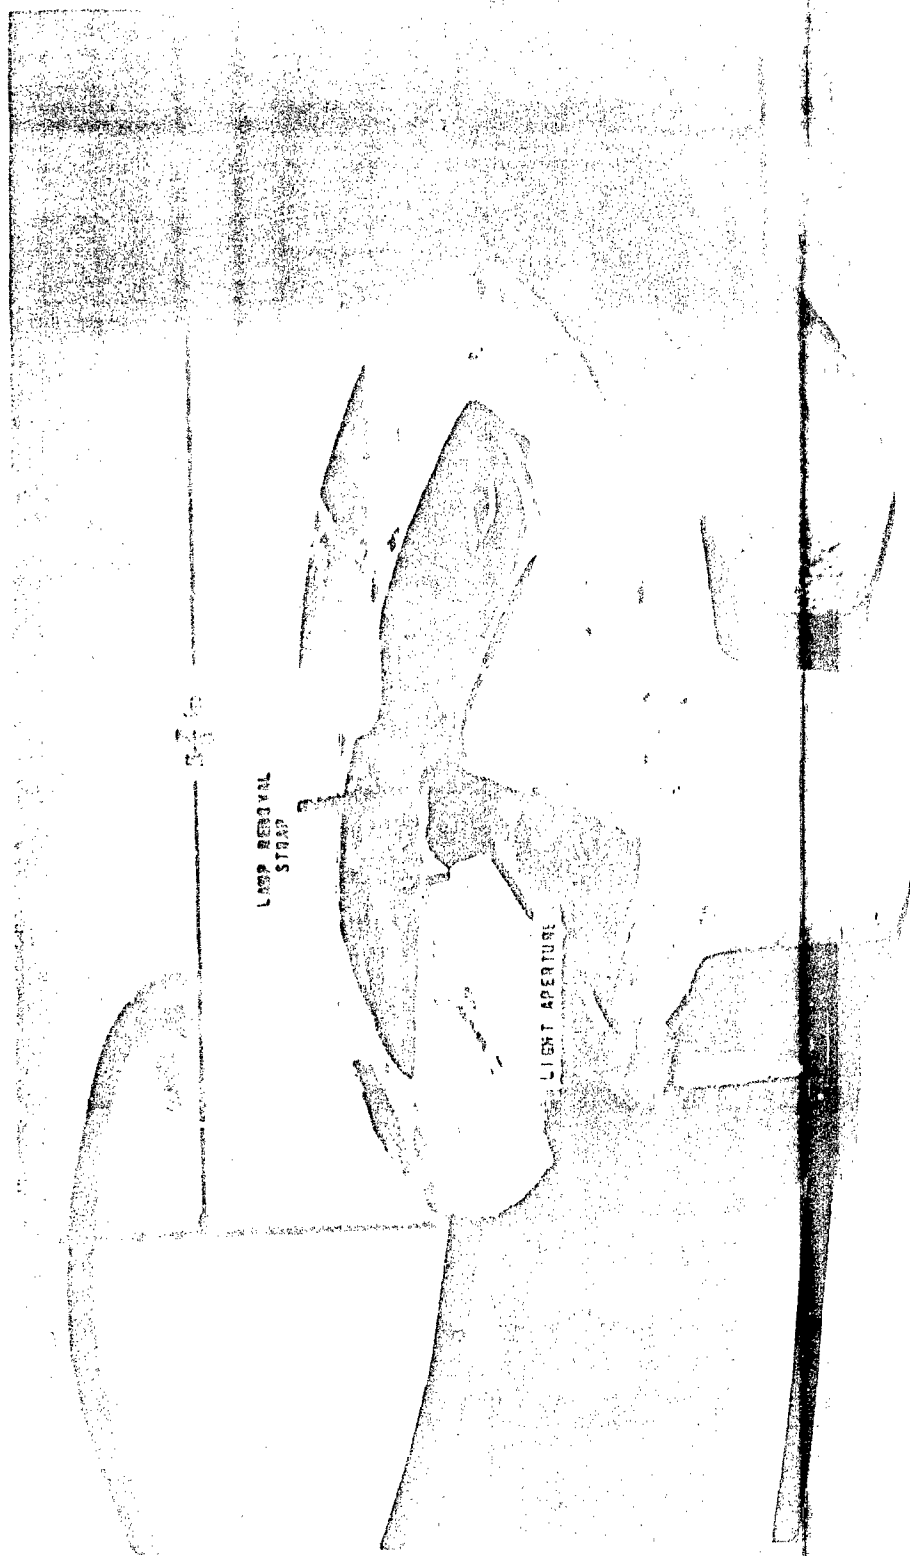
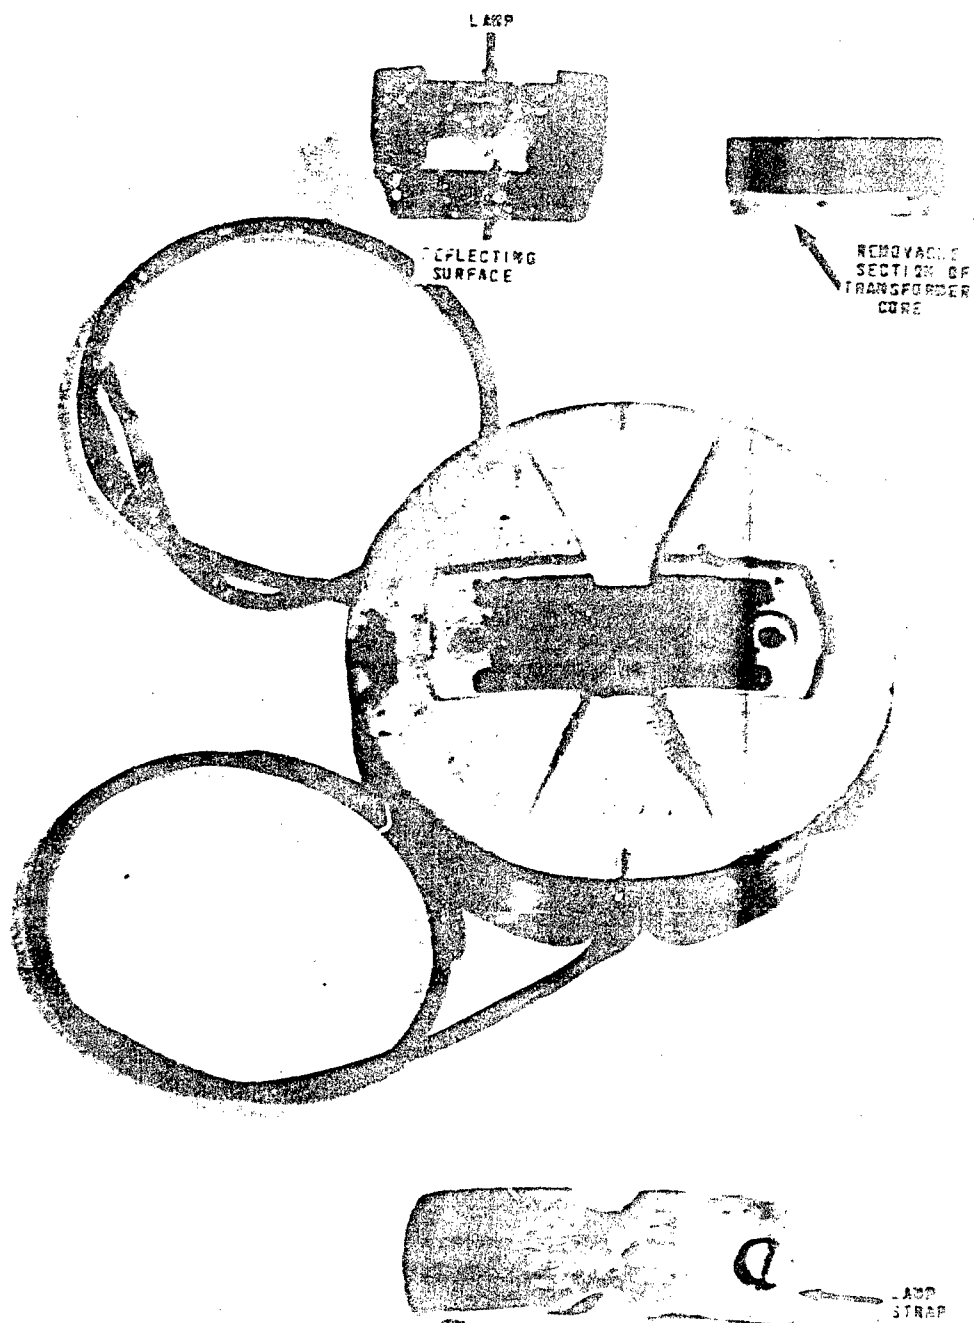
FIG. 8 STRONG ELECTRIC CORPORATION'S 5 7/8-INCH FIXTURE

FIG. 9 STRONG ELECTRIC CORPORATION 5 7/8-INCH FIXTURE
(LAMP STRAP REMOVED)

inches high at the center. It extends $1/4$ inch above the runway surface when installed. The smaller fixture is $5-7/8$ inches in diameter (FIGS. 8 and 9) and $2-1/8$ inches high at the center. It extends $3/8$ inch above the runway surface when installed. The Strong Electric Corporation fixtures have no provisions for installing colored filters. The lamp terminals in this fixture are mounted in a rigid plastic material.

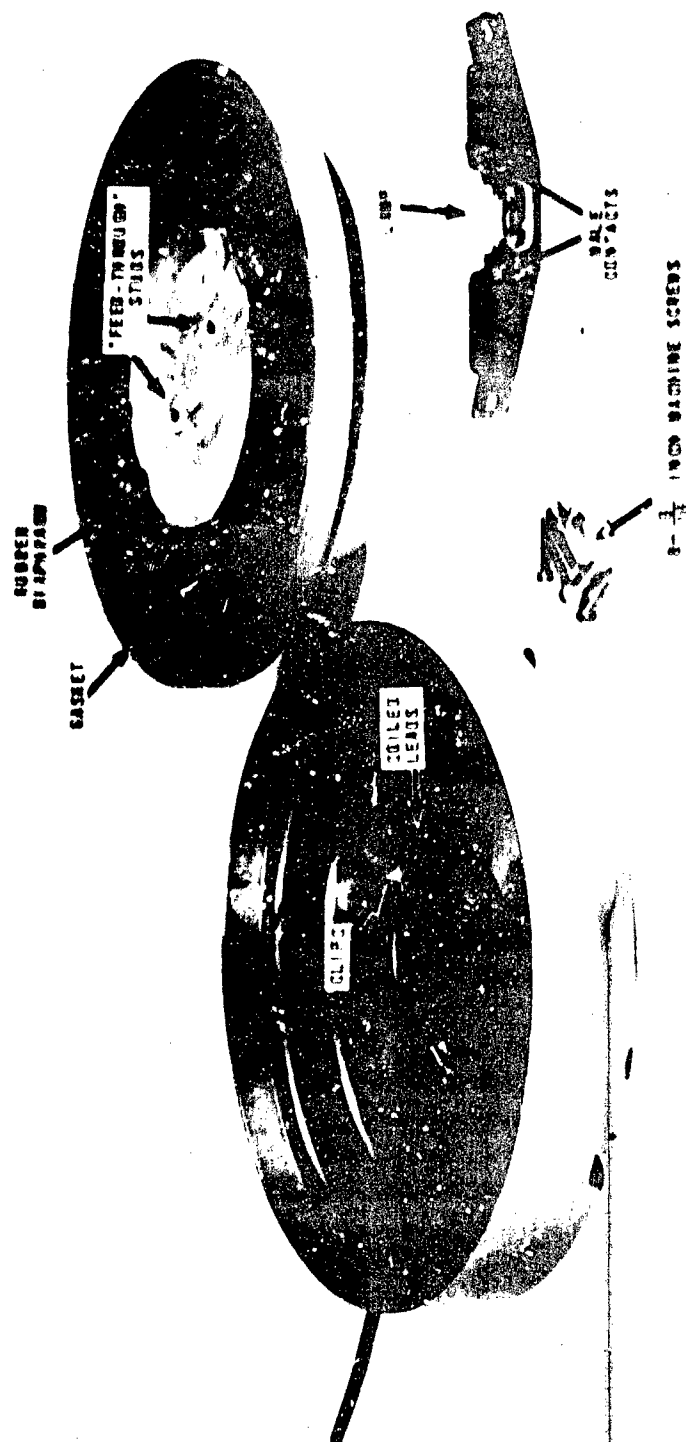
FIG. 10 STIMULANT RUBBER COMPANY FIXTURE

FIG. 11 STILLMAN RUBBER COMPANY FIXTURE
(TOP ASSEMBLY AND LAMP STRAP REMOVED)

Stillman Rubber Company Fixtures - The Stillman Rubber Company fixtures (FIGS. 10 and 11) are connected in series circuits with a film cutout connected in parallel with each lamp. It is $7-15/16$ inches in diameter, $1-13/16$ inch high at the center, and extends $9/16$ inch above the runway surface when installed. The center part of the top assembly containing the lamp is mounted within the rubber diaphragm. The top assembly is attached to the base assembly by eight $9/16$ inch machine screws holding a mounting ring to which the diaphragm is attached. An aircraft rolling over the top assembly depresses the lamp assembly flush with the rim of the base assembly (or runway surface). Air, compressed by the downward force, cushions the impact and returns the top assembly to its normal position once the aircraft has passed. The rubber diaphragm is $1-3/16$ inch wide and $1/8$ inch thick between the mounting ring and the center part of the top assembly. A wedge shaped portion of the rubber extends $1/16$ inch below the top assembly to cushion the impact of the top assembly when bottoming occurs against the base assembly. A portion of the molded rubber serves as a gasket to seal the unit at the outer rim of the base assembly adjacent to the machine screws. Current is delivered to the lamp in the top assembly through leads that are $7-1/4$ inches in length, coiled in a loop beneath the center part of the top assembly, and attached to connectors in the base assembly. The lamp terminals are mounted in rubber. A recess is provided beneath the lamp strap for mounting filters in the fixture.

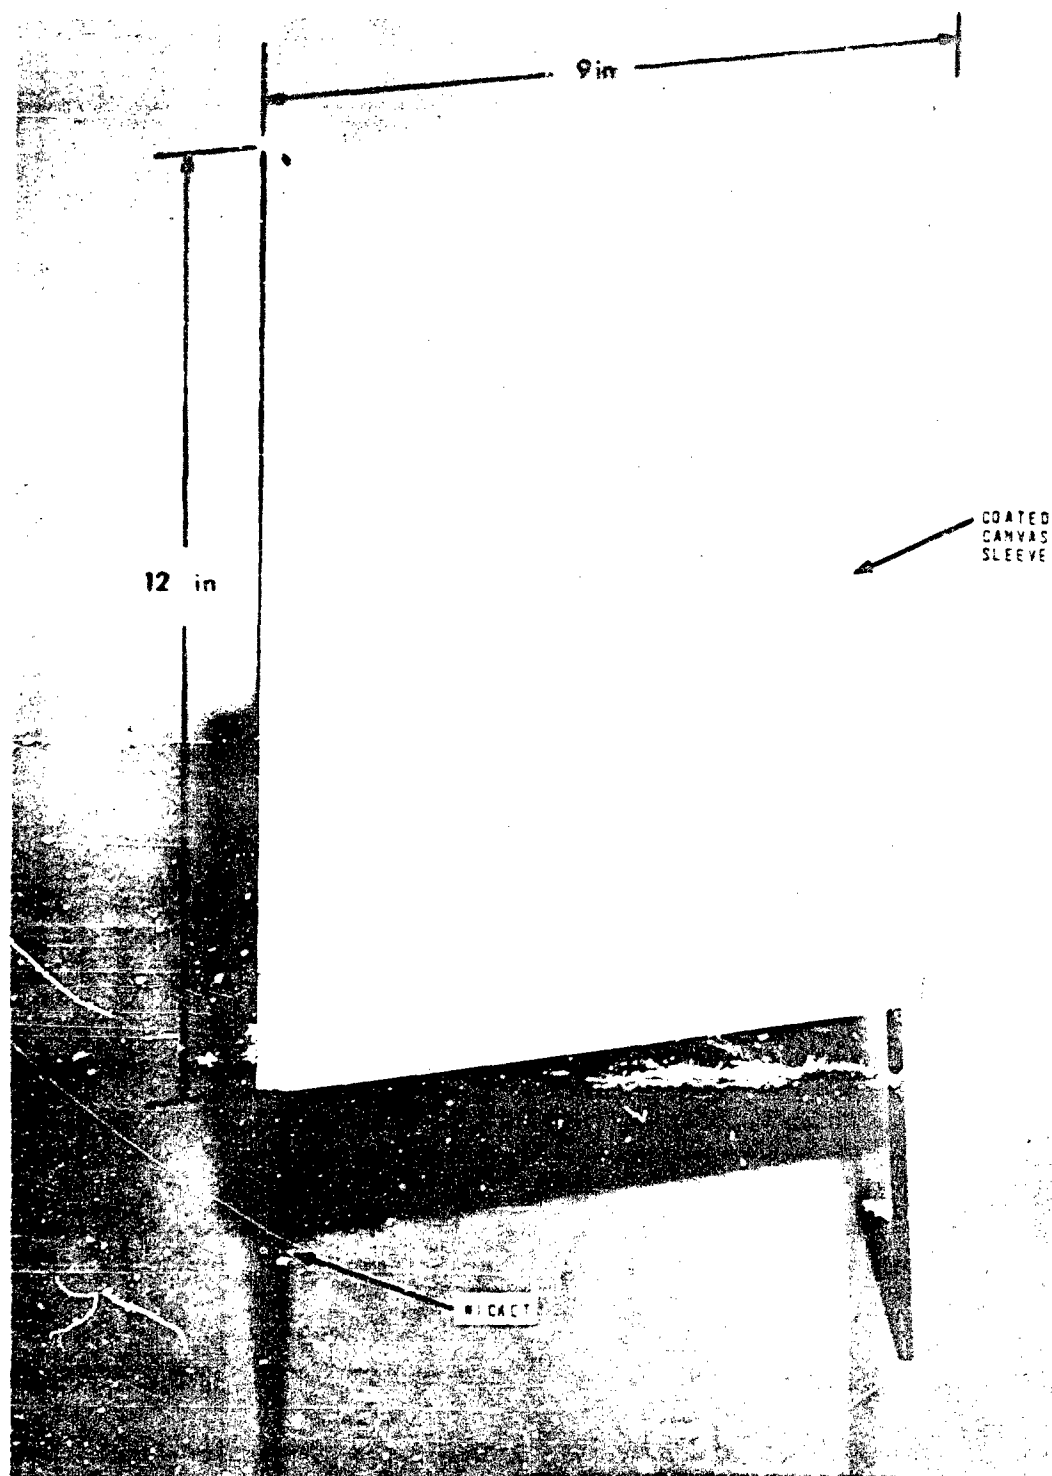
FIG. 12 MINNESOTA MINING AND MANUFACTURING COMPANY
REFLECTIVE MARKER

Reflective Markers: The reflective edge marker (FIG. 12), trade named "Silver Airport Wicket," consists of a $1/8$ inch diameter wire strand, shaped like a wicket, with a reflective canvas sleeve pulled over it. The sleeve is 12 inches long and 9 inches wide and coated with a reflective material on its outer surface. The marker is installed by pressing its wire ends into the ground. The reflective edge markers are manufactured by the Minnesota Mining and Manufacturing Company under Specification Number MIL-R-726A. The markers were installed adjacent to each taxiway edge light along Taxiways B, G, and E.

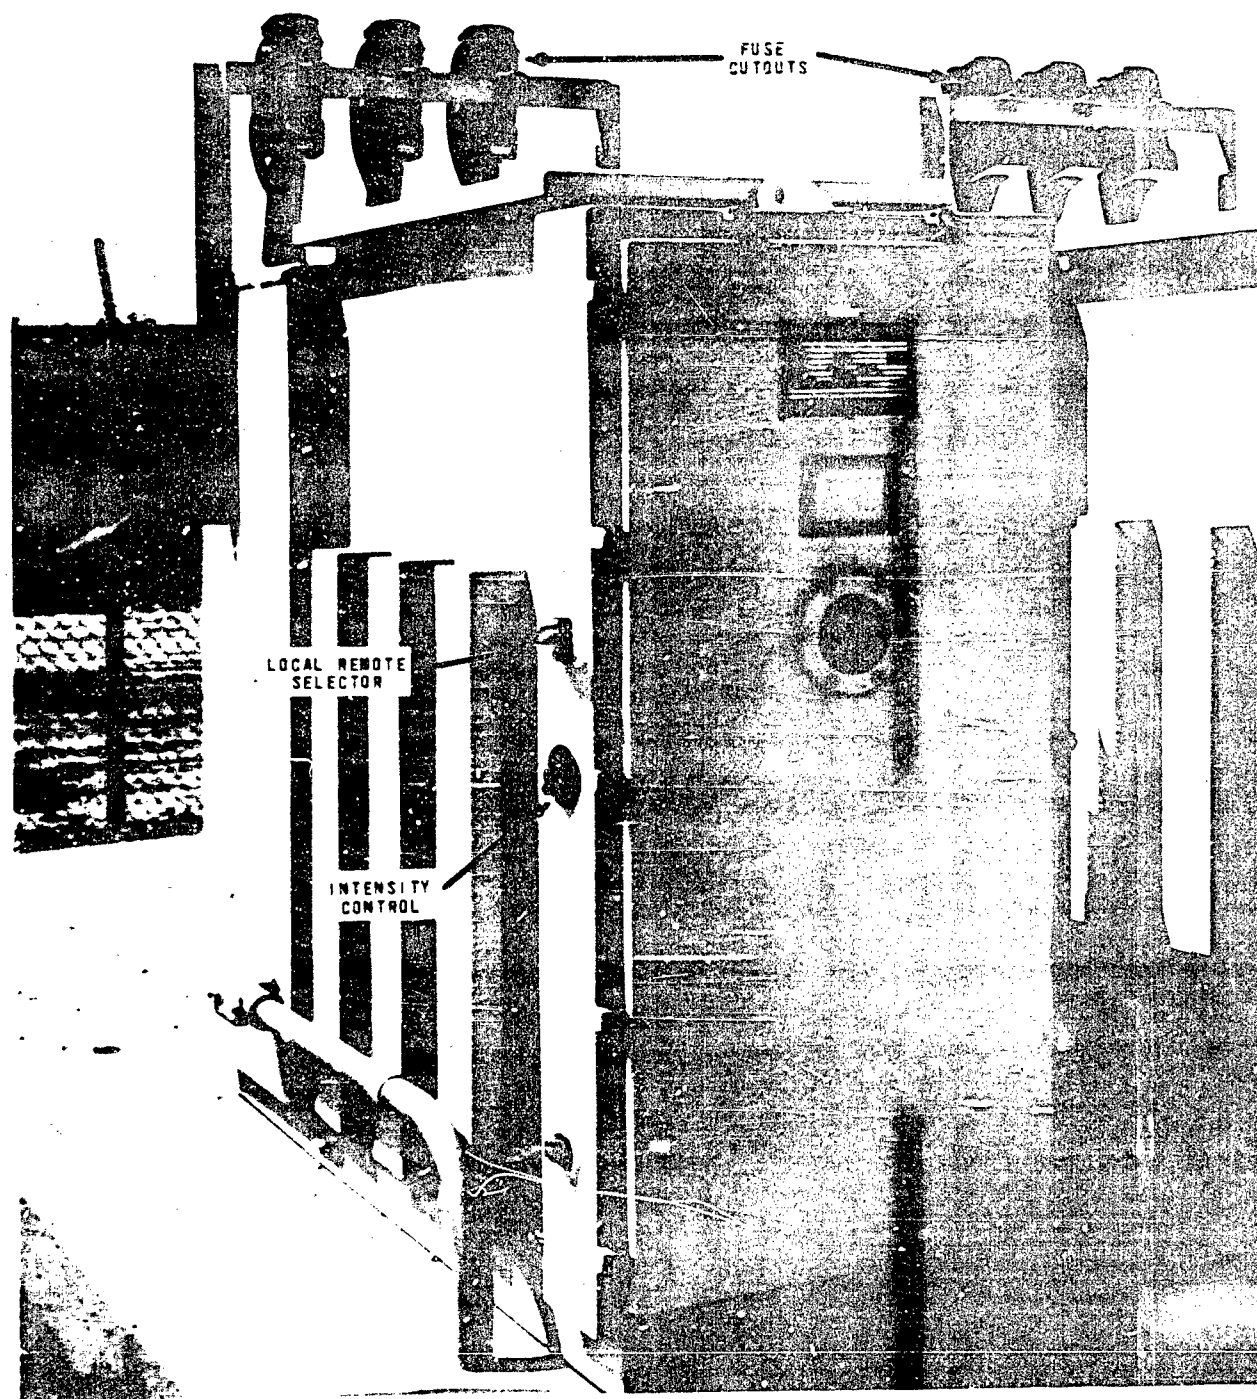
FIG. 13 HEVI-DUTY ELECTRIC COMPANY CONSTANT CURRENT REGULATOR

Power and Control: Power for the taxiway centerline lighting systems was regulated by three 20 KW, 180-cycle, 4160/2300 volt, constant current regulators manufactured by the Hevi-Duty Electric Company (FIG. 13) and controlled by a panel (FIG. 14) located in the NAFEC experimental lighting control and power distribution center. The 180-cycle power was required to permit use of small transformers molded into the base of the Strong Electric Corporation Fixtures.

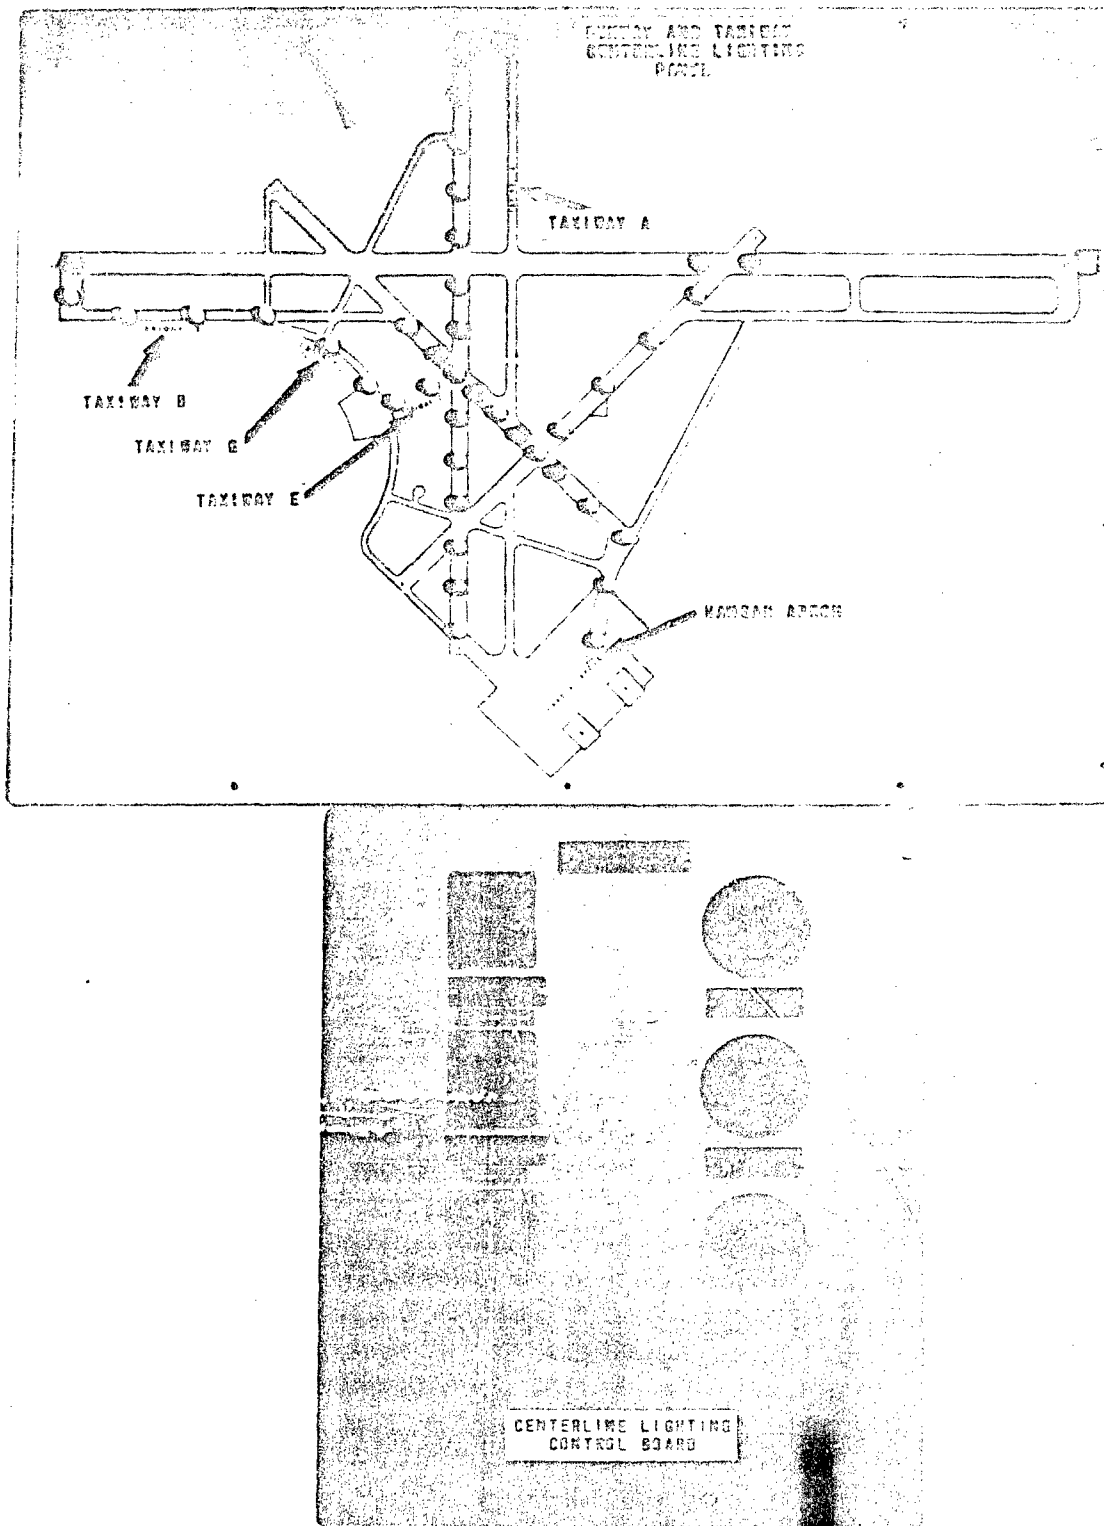
FIG. 14 TAXIWAY CENTERLINE LIGHTING CONTROL PANEL

Selector switches were installed to permit the operator to select either right or left turns from straight taxiway sections as well as to select lighting for straight sections only.

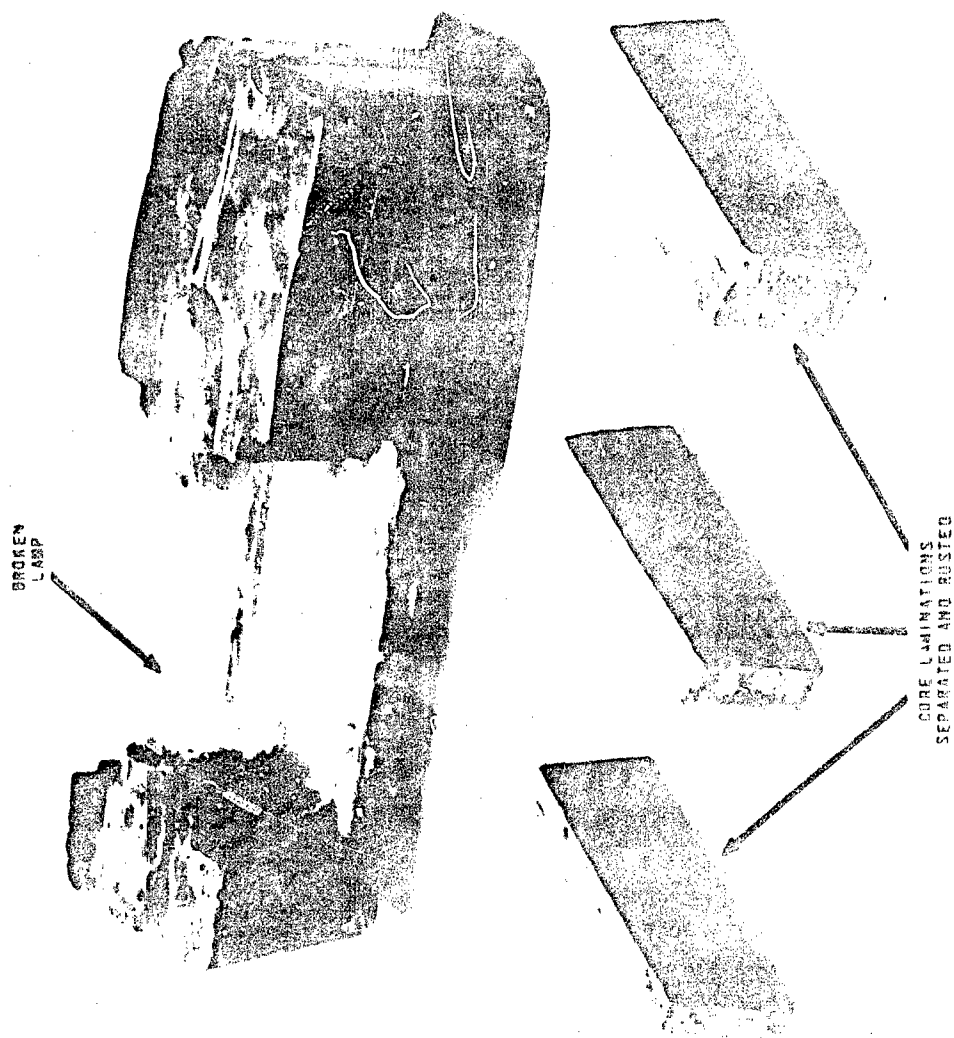
FIG. 15 DAMAGE TO COMPONENTS OF THE 7 13/16-INCH
STRONG ELECTRIC CORPORATION FIXTURE

Strong Electric Corporation Fixture: Ice expansion in the recesses of both the 5-7/8 inch and 7-13/16 inch fixtures caused the lamps to crack or shatter. Freezing of these fixtures made it very difficult to remove the lamp assembly for repairs. Efforts to pry the lamp assembly free of the fixture resulted in breaking the strap of the fixture away from the lamp assembly.

In addition to the ice damage, numerous transformer cores were rusted and core laminations were separated (FIG. 15).

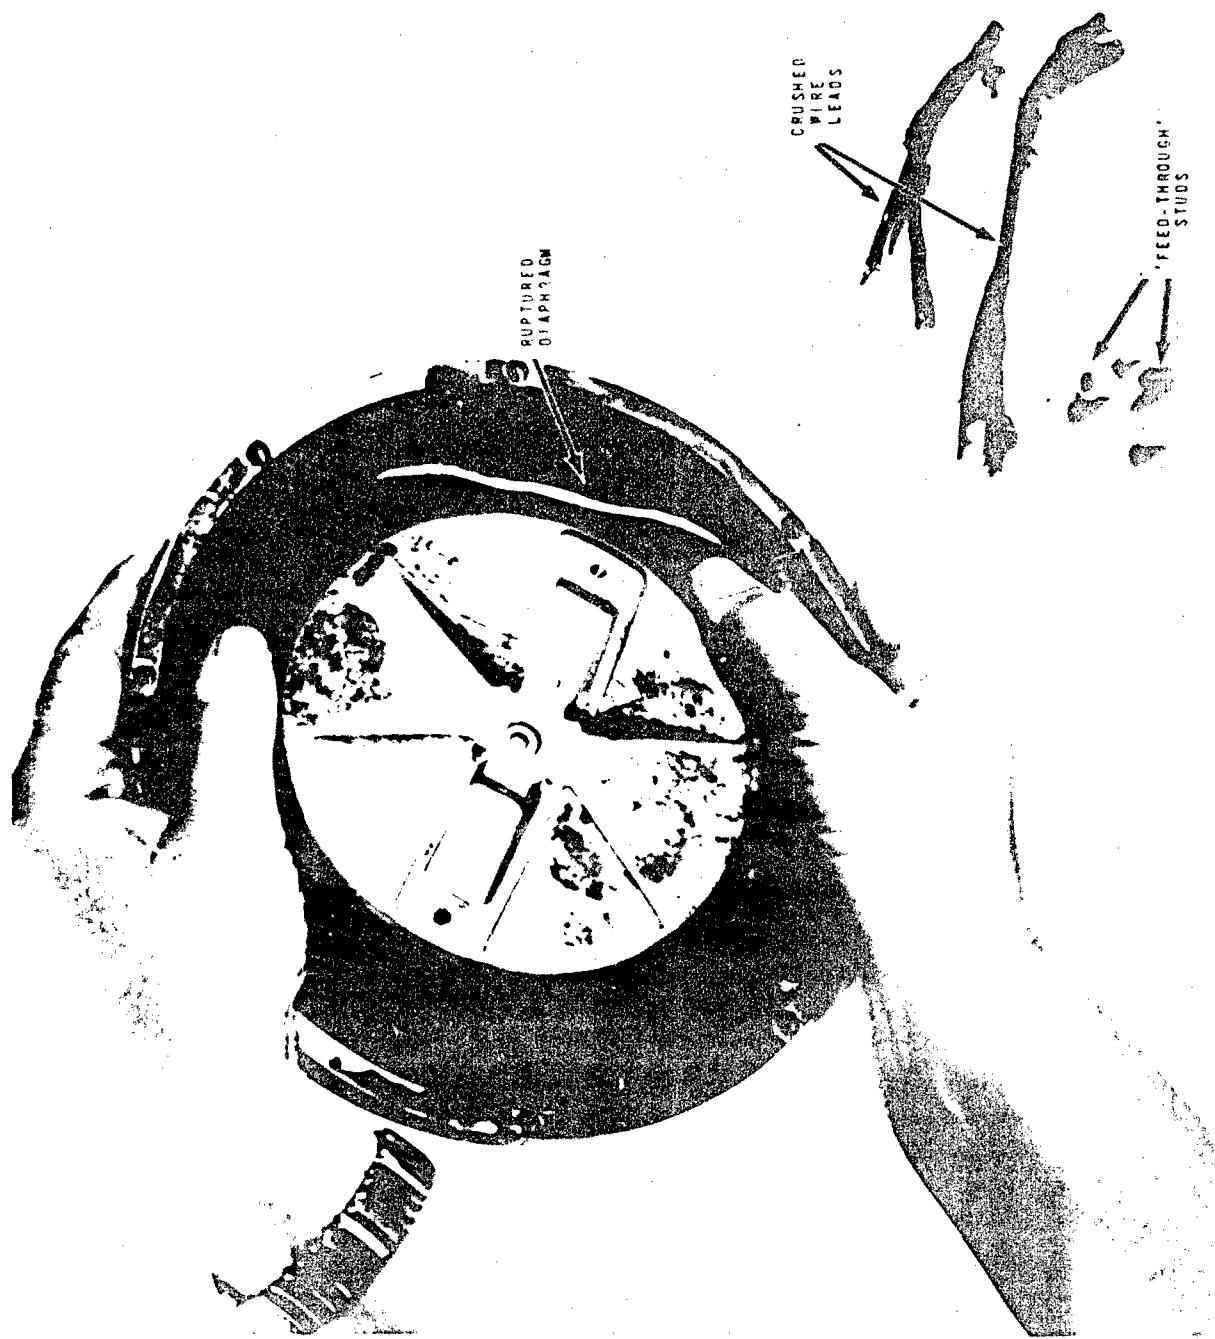
FIG. 17 EXAMPLE OF SEVERE RUBBER DIAPHRAGM DAMAGE SUSTAINED BY
STILLMAN RUBBER COMPANY FIXTURE

Stillman Rubber Company Fixtures: The rubber diaphragms of the Stillman Rubber fixtures were unable to withstand repeated aircraft tire strikes. Hairline cracks in the rubber appeared shortly after installation and these cracks gradually become larger (FIGS. 16 and 17). A summary of rubber diaphragm failures from May 1962 through March 1963 is shown in Table IX.

Inspection of the individual fixtures proved to be difficult because the top assembly could not be easily removed. The top assembly became wedged in the base assembly because of the initial tight fit of the top assembly and the added pressure applied to the rim of the base after installation. The Stillman Rubber Company modified a lamp strap into a tool for removing the top assemblies, but it bent because of inadequate strength. A heavier tool was then fabricated at NAFEC which permitted removal of the top assemblies. Inspection revealed that crushed or broken wires between the studs in the top assembly and the power leads was the primary damage. Attempts to repair the electrical damages proved to be costly and time consuming and thus were discontinued. Periodic visual inspection of the fixtures was continued, however.
